Note of Footplate Inspection of Kavach installation in ECR on 12.06.2024 by
Lalit K Mansukhani, OSD/CoE(Modern Signalling-Kavach)

Inspection through footplate on Kavach fitted Loco Movement was carried out in Up and Down Directions in Section from Anugrah Narayan Road to Deo Road and back. Section and Onboard Kavach and RFID Tag formats - all were latest Draft Ver 4.0 (Unapproved) as on day of Inspection.

IRISET/CoE/Kavach/Misc

03.07.2024

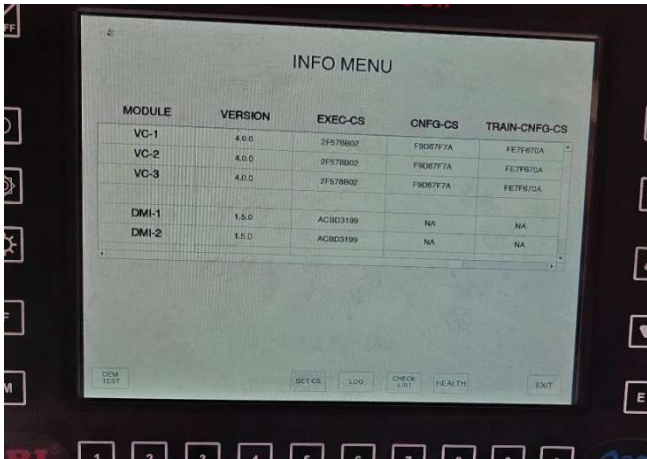
| SN | Actionable Item | Action By |
|---|---|---|
| 1 | <p>The Checksum information of Onboard Kavach Firmware (software) through DMI on the day of inspection was as shown here. It was confirmed by the HBL Engineer that it was latest checksum on that day of Inspection. However, he couldn't explain traceability of changes/ Version Control/Date.</p> <p>(a) Procedure needs to be setup to verify through Version Controlled Checksum whether the Software used during inspection is latest or not. Such discipline was enforced even during Core R&D for development of SIL-4 multi-vendor interoperable product through field trials from 2013-end to 2015. On adding Passenger Carrying/ Coaching trains in field trials from Feb-2016 onwards, all changes were notified through a Group to keep track of changes with compilation of each use case in monthly Report. It is high time to restore good old practice to have smooth development and clearance from Independent Safety Assessor (ISA).</p> <p>(b) It is advised to make the display more informative by adding Loco Number, Version and Date with Checksum, Parameters undergoing updates during Shed Visit such as Wheel Dia etc, Timestamp of Previous Shed Visit, Timestamp of Previous functioning of Onboard Kavach in Kavach territory.</p> | RDSO CoE Medha HBL Kernex GG Tronics QFTL |

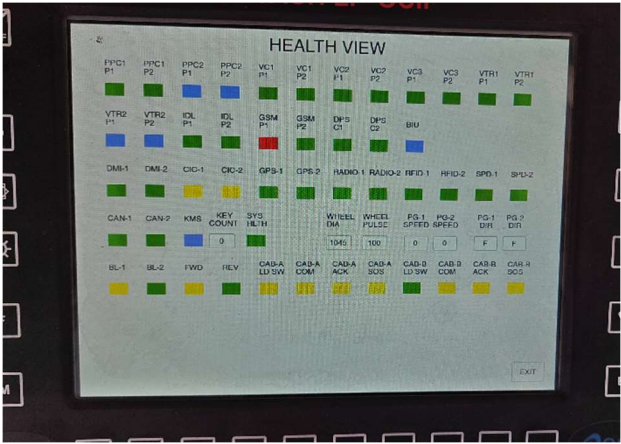
| SN | Actionable Item | Action By |
|---|---|---|
| 2 | <p>In order to have secure radio communication, there is provision of acquiring Authentication Key Sets by Stationary-Kavach and Onboard Kavach for 120 days initially from Centralized "Key Management Server (KMS) and to top up whenever it goes below 60 days. It is acquired through SIM card (Commercial Mobile Network) irrespective of whether the Onboard Kavach is in Kavach territory or not. The functioning of Onboard Kavach cannot start without any Authentication Key.</p> <p>All officials (OSD/CoE, ASTEs from ECR and OEM HBL Personnel) and Kavach equipped Locomotive reached well before time at Anugrah Narayan Road Station but Onboard Kavach didn't possess any Authentication Keys, which caused some delay in commencing the inspection. On insertion of SIM cards by HBL personnel in Vital Gateway Card, the Onboard Kavach acquired Authentication Keys and got ready for Kavach functioning.</p> <p>(a) Further, even after acquisition of Authentication Key Sets, the DMI display continued to show "Nil" Authentication keys due to software glitch. The software was modified post-inspection to reflect it correctly.</p> <p>(b) To avoid delays and to utilize path, it is prudent to check availability of Authentication keys well before bringing Onboard Kavach Locomotive in section for field trials.</p> <p>Post-inspection, a Video Conference was convened by CoE on 14.06.2024 with relevant Stakeholders (CoE, RDSO, ECR, Railway Board, 03 OEMs) to address the related issues. MoM of VC have been issued separately.</p> | OEM HBL |

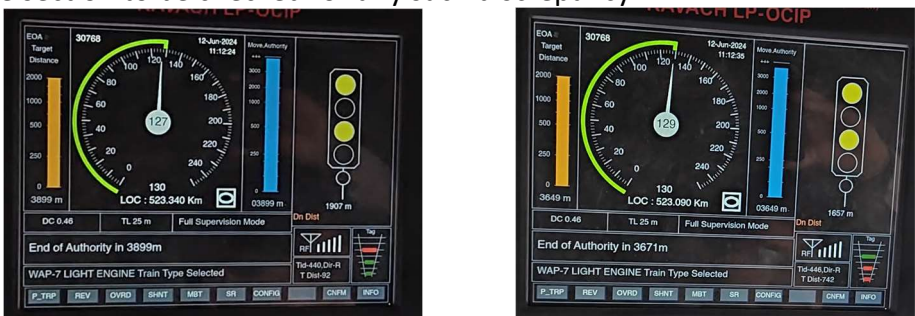
| SN | Actionable Item | Action By |
|---|---|---|
| 3 | <p>Due to mismatch in Tag Data and their placement location, RFID tags 442 and 444 appeared as missing on DMI. It may be rectified on priority at site and the whole section to be checked for any such discrepancy.</p> | OEM HBL ECR |

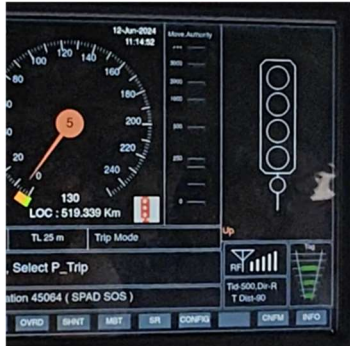
| SN | Actionable Item | Action By |
|---|---|---|
| 7 | <p>Once overshooting of End of Authority (EoA) / SPAD is detected, Emergency Brake would be applied by Kavach. It appears from the DMI indications that the Brake Command by Kavach was withdrawn as the speed fell below 5 kmph. It is desirable not to withdraw the Emergency Brake Command until train comes completely to stop in such case. This aspect may be verified at falling gradient by Dir-I/T&RS/CoE/Kavach.</p> <p>It occurred later at other occasions also during the inspection.</p> | <p>OEM HBL CoE RDSO</p> |

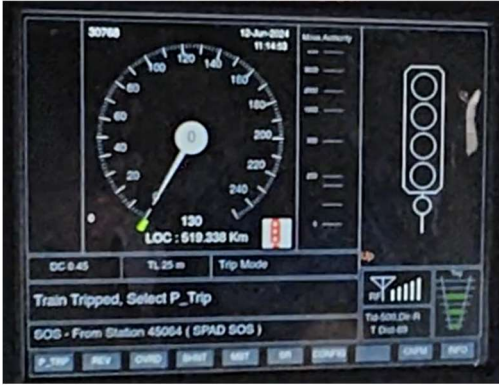
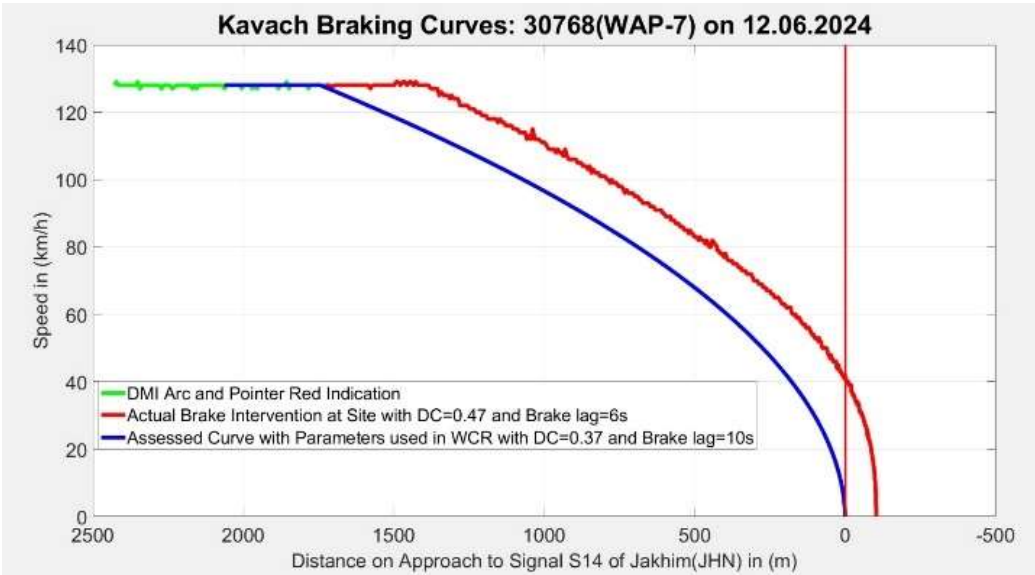
| SN | Actionable Item | Action By |
|---|---|---|
| 8 | <p>Locomotive stopped at km 519.338 i.e 111m after crossing the Signal (shown below in Red Curve). HBL had used DC=0.47 kg/sq.cm, Brake Lag=06 Sec as approved by RDSO. Had DC and Brake Lag been 0.37 kg/sq.cm and 10 Sec (As cleared by CoE in WCR field trials), it would have stopped before Signal at Danger, as shown below in Blue Curve.</p> | OEM HBL CoE RDSO |

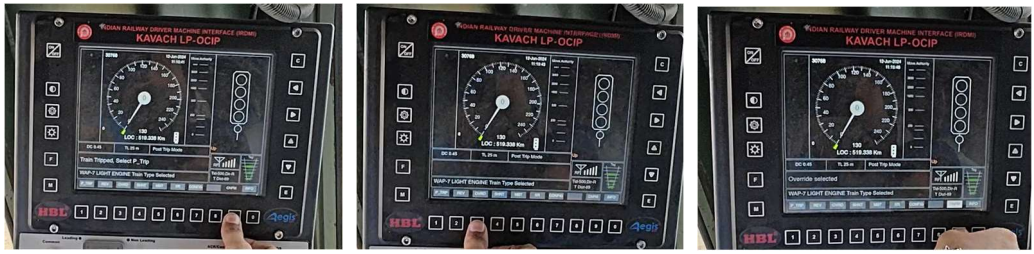
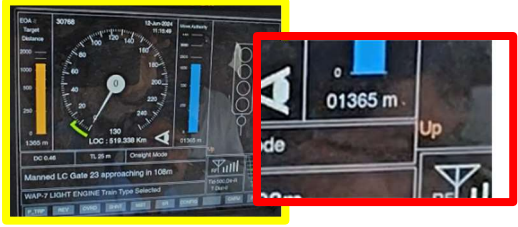
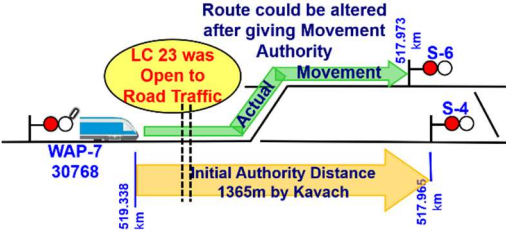
- (A) In Kavach Ver 4.0, the OS MA in yards is being unduly sent to Onboard without ensuring fulfilment of requisite conditions. Indicating On Sight Mode to LP and giving Authority to Onboard Kavach without ensuring Locking of points, Closure of LC Gates etc is similar to taking off Calling-On Signal without Locking of points, Closure of LC Gates, which is not safe. {Item (9) of Enclosure}.

- (D) Any lineside signal provides protection and authority beyond its location (not on its approach). However, as per current implementation, those Movement Authority and Permitted Speed, which do not pertain to the Onboard Kavach under subject, are also applied to it. It needs to be discontinued {Item (9) of Encl}.

| SN | Actionable Item | Action By |
|---|---|---|
| 9 | <p>On invoking Override at km 519.338, the Onboard Kavach immediately entered in On Sight (OS) Mode with display of On Sight Movement Authority.</p> <p>Further, the Authority (1,365 m) displayed was corresponding to Mainline (S6 at km 517.973). $519.338\text{km} - 517.973\text{km} = 1,365\text{m}$</p> <p>The train was actually routed to Loopline. On investigation through conventional signalling datalogger, it was learnt that the route was not locked while giving Movement Authority, therefore it could be altered by Station Master to Common Loopline (S4 at 517.965km) after giving Movement Authority.</p> <p>The Authority Distance is subsequently adjusted in non-radio based ETCS L-1 through Repositioning Balise. The Aspect of the signal at divergence (such as Calling-On Signal) is not able to distinguish between locked routes in ETCS Level-1. Therefore, the relevance of Repositioning Balise in radio-based ETCS L-2 is not same as in ETCS L-1. Same applies to radio-based Kavach.</p> <p>It was learnt on investigation through Signalling Datalogger that the route was not locked and the LC Gate also was open initially. On seeing approaching Locomotive, Gateman lowered the booms.</p> <p>Kavach unduly provided Movement Authority without ensuring locking of route, closure of LC Gate to Road Traffic i.e without actually having authority. This needs design modification. CoE has advised RDSO for not giving Movement Authority without protection by route (latest reiteration vide letter 19.01.2024). This is in line with the fact that any lineside signals provide protection and authority beyond its location (not on its approach). Moreover, Kavach displayed Movement Authority distance to Train Pilot in On Sight Mode as newly introduced “feature” in Kavach Ver 4 Spec.</p> | RDSO All OEMs |

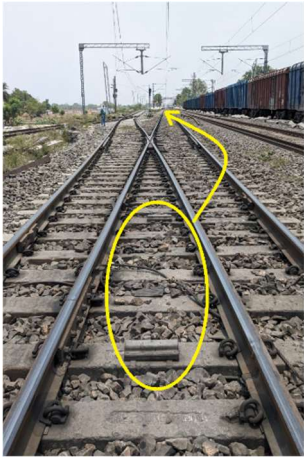
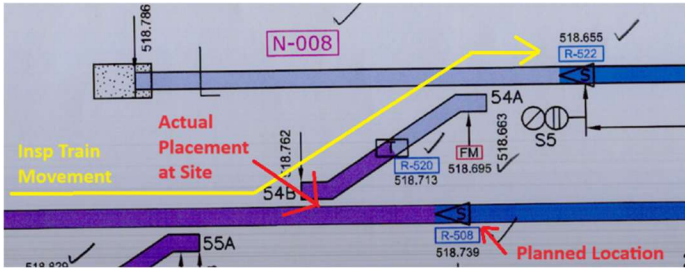
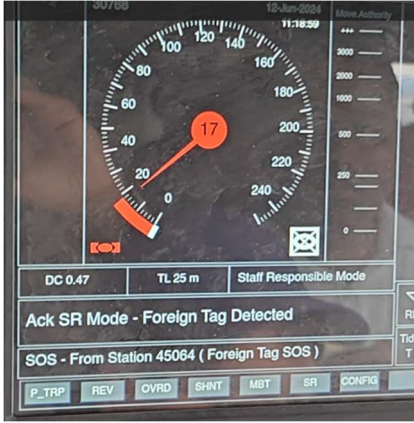
| SN | Actionable Item | Action By |
|---|---|---|
| 11 | <p>RFID Tag 508 at Jakhim Station was planned on Mainline but placed at common Crossover.</p> <p>Such improper placement caused this mainline RFID tag to get unduly read even for Loopline Movement with point 54 Reverse. This unexpected tag reading was considered as wrong routing of train and brakes were applied. This needs to be set right at site on priority.</p> | OEM HBL ECR |

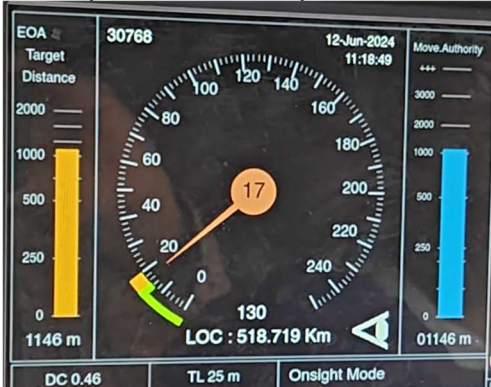
| SN | Actionable Item | Action By |
|---|---|---|
| 12 | <p>When Locomotive was still on berthing track at Location km 518.719 only, the On Sight Movement Authority by Kavach suddenly increased ~400m beyond both (Mainline and Downline) starter signals at 11:18:49. It again got restored at 11:18:53 when the Movement Authority Distance fell by ~400m.</p> | OEM HBL |

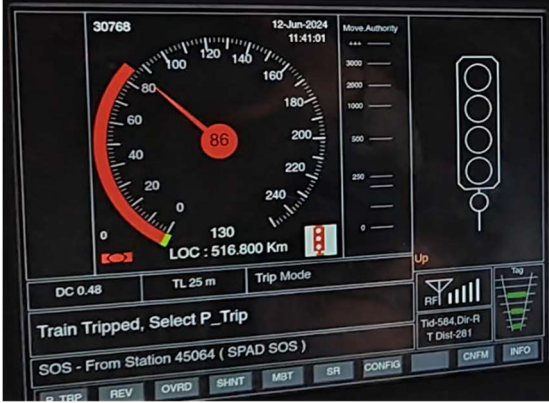
| SN | Actionable Item | Action By |
|---|---|---|
| 13 | <p>On crossing the tag 584, the Movement Authorities were suddenly withdrawn at Time 11:41:01 Hrs resulting into sudden Emergency Brake Application from speed of 86kmph.</p> <p>After analysis, a glitch was found in the Ver 4.0 software by OEM HBL software logic while handling of Adjustment Tag. The modification in software had to be carried out by OEM HBL to set right the glitch. Corrected Software will be loaded with altered Checksum by OEM in EC Railway and elsewhere.</p> | OEM HBL |

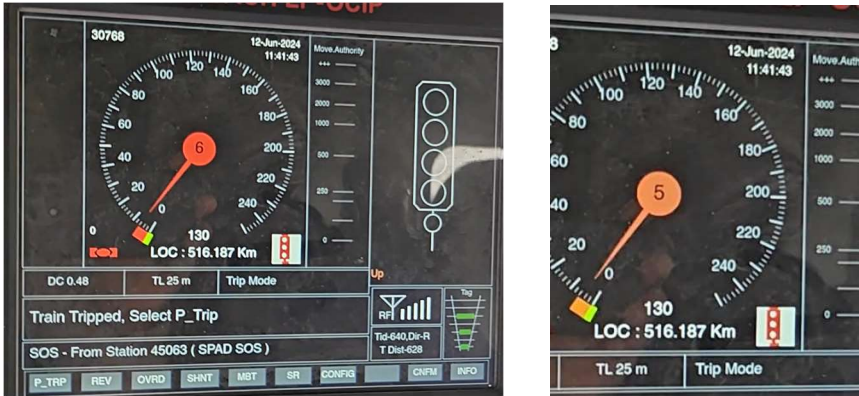
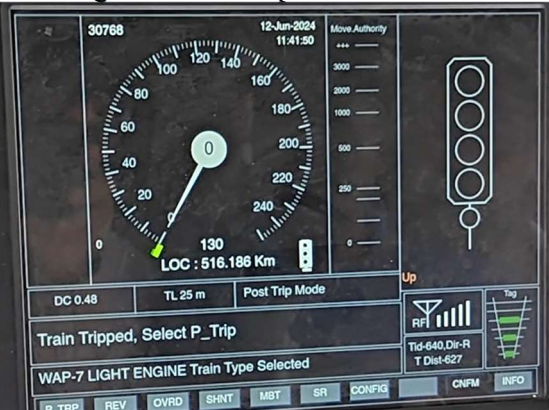
| SN | Actionable Item | Action By |
|---|---|---|
| 14 | <p>Once overshooting of End of Authority (EoA) / SPAD is detected, Emergency Brake would be applied by Kavach. It appears from the DMI indications that the Brake Command by Kavach was withdrawn as the speed fell below 5 kmph. It is desirable not to withdraw the Emergency Brake Command until train comes completely to stop in such case. This aspect may be verified at falling gradient by Dir-I/T&RS/CoE/Kavach.</p> <p>Onboard Kavach was brought to Post Trip at time 11:41:50 Hrs.</p> | OEM HBL CoE RDSO |

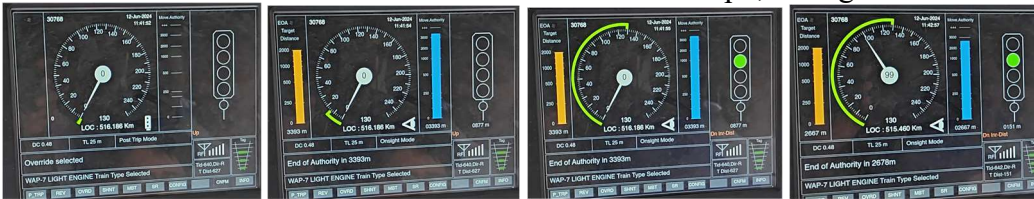
- (E) Display of “Down” as “Up” took place at numerous places due to Software Glitch. RDSO vide recent Amendment dtd 21.06.2024 in Spec Ver 4.0 has reduced the RFID Reader Height by 100mm {Item (15) of Encl}. RDSO may reconsider solution proven in field in 2016.

| SN | Actionable Item | Action By |
|---|---|---|
| 15 | <p>On selecting Override at 11:41:52, Onboard Kavach immediately turned to On Sight Mode at Time 11:41:53, Location km 516.186 with Display of On Sight Movement Authority as 3393m, with Direction exhibited wrongly as “Up”. After 02 Sec, at 11:41:56 Hrs, the “Proceed (G)” Signal Aspect was displayed on DMI with Permitted Speed as 130kmph. It will be difficult for Train Pilot to be “On Sight” for any obstruction ahead in form of train ahead at 130 / 160 kmph; arrangement needs review.</p> <p>Although the train was moving in Down Direction, display of “Up” continued until 11:41:54 as shown above. Such incorrect display occurred multiple times during the inspection, at times for prolonged duration.</p> <p>Direction determination (Nominal/Reverse) is SIL-4 functionality. Off-late, determination of direction through multiple tags of same tag set has been introduced in Ver 4.0. CoE had raised apprehensions vide letters 22.09.2022 and in recommendations in CoE Letter 04.01.2023. Such determination of direction is not solicited in view of CoE Letter 19.01.2024. However, RDSO vide recent alteration dtd 21.06.2024 in the Spec, has changed nominal height of RFID Reader from 450mm to 350mm vide Kavach Ver 4.0 SRS Annexure-F Amdt-1. The solution worked out during field trials on passenger carrying trains in 265km section of SC Railway in 2016 by taking considered decision on 14.07.2016 vide Part(1) of NP-23 of concerned Vol.9 of Signal Dte file of RDSO was implemented in Ver 3.2 in field and Control Tables but has been withdrawn in Ver 4.0. Same may be reviewed to avoid undue SoS {CoE Ir 25.07.2023, 28.12.2023}.</p> | OEMs RDSO |

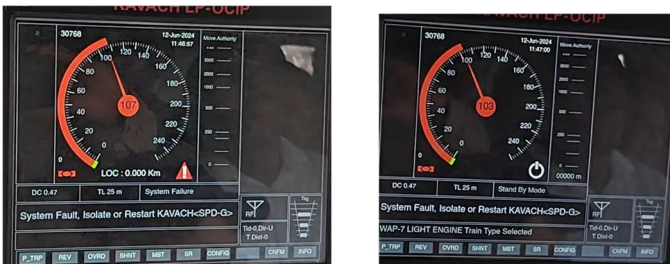
| SN | Actionable Item | Action By |
|---|---|---|
| 17 | <p>System Failure occurred at 11:46 with application of Emergency Brake from 107 kmph, in the zone of RFID Tags 704, 706 etc. System transited from System Failure Mode to Standby Mode on its own on run at 11:47:00 and Emergency Brake continued. This event occurred while leaving Deo Road Station in Down Direction. On 01.07.2024, OEM HBL confirmed the irregularity and assured of rectifying the problem.</p> <p>It was observed regarding RFID tags of same tag set that there were mismatches in sequences of Physical Installation at site along the direction of travel Direction and their reporting to Vital Computer. Recent modification dtd 21.06.2024 in Specs needs testing at higher speeds, rework in Locos already fitted with Kavach</p> | OEM HBL RDSO |

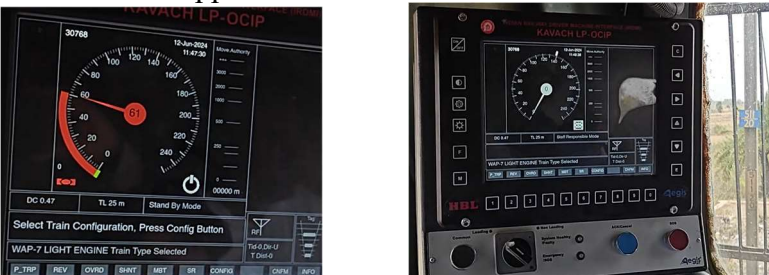
| SN | Actionable Item | Action By |
|---|---|---|
| 18 | <p>The system prompted for Selection of Train Configuration etc on run. It may be reviewed. Locomotive stopped near to OHE Mast 511/20.</p> | OEM HBL RDSO |

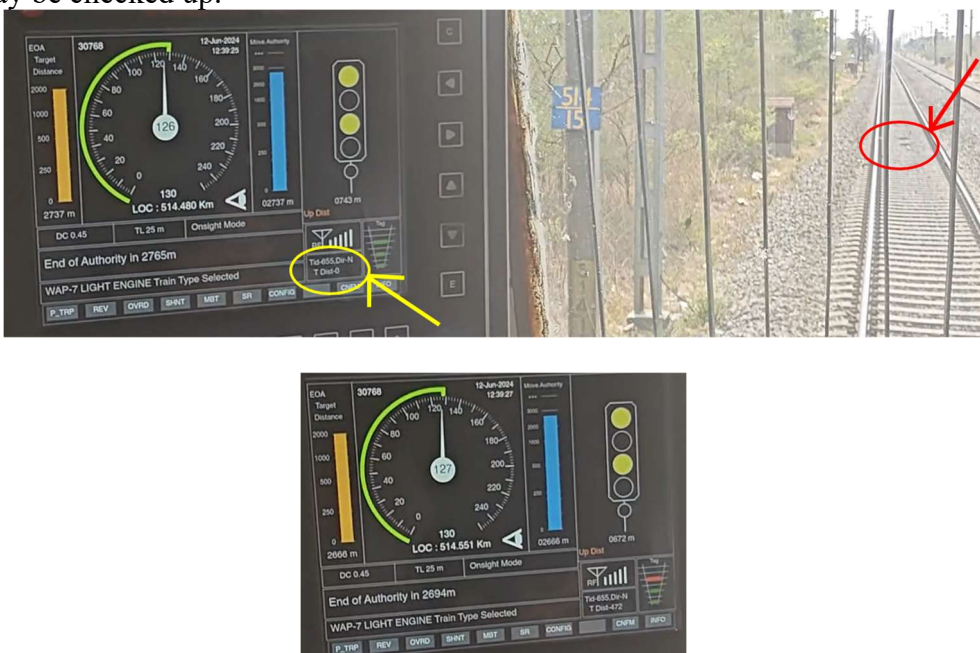
| SN | Actionable Item | Action By |
|---|---|---|
| 19 | <p>Adjustment Tag No. 581 was read by the Onboard Kavach. However, it was declared as missing tag by Onboard Kavach. Distances / Location/ Tag Data etc may be checked up.</p> | OEM HBL ECR |

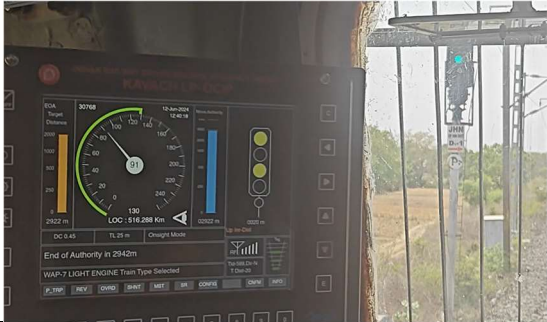
| SN | Actionable Item | Action By |
|---|---|---|
| 20 | <p>The Physical Lineside Signal on Approach exhibited Proceed (Green) aspect whereas it shows Attention Aspect (YY) on DMI (12:40:18). It may cause confusion to Train Pilots.</p> | OEM HBL |

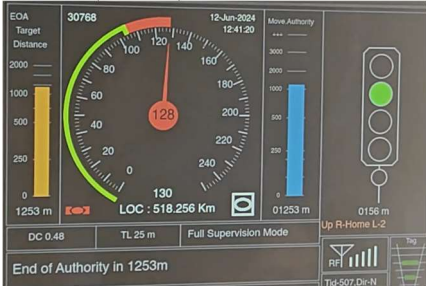
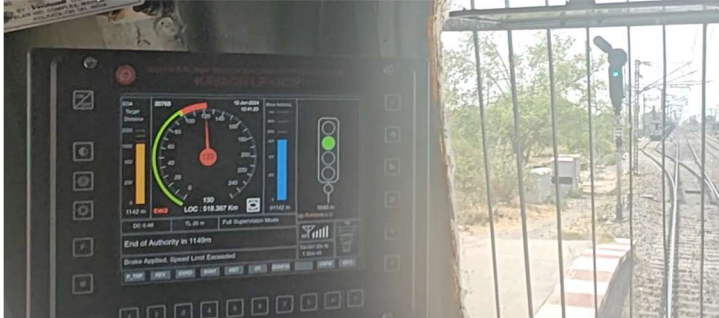
| SN | Actionable Item | Action By |
|---|---|---|
| 21 | <p>The Movement Authority sent by S-Kavach was inadequate and around 1.1 km only beyond Signal at Proceed (Green).</p> <p>It resulted into Emergency Brake Application at 12:41 when Signal was actually exhibiting Green (Proceed) Aspect.</p> <p>It was set right after passing RFID Tag no. 509 at foot of Home Signal (wrongly labelled at Routing Home on DMI).</p> | OEM HBL RDSO |

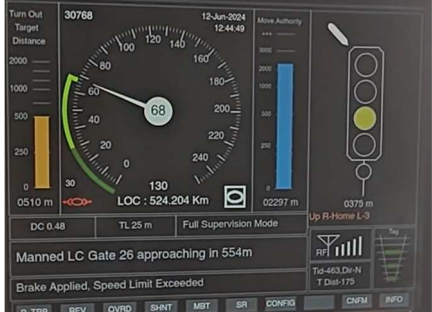
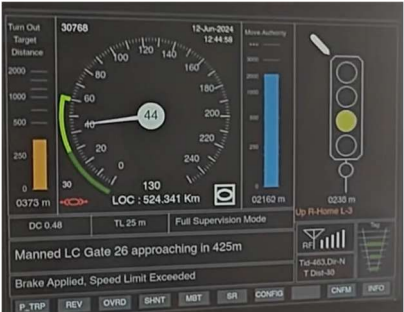
| SN | Actionable Item | Action By |
|---|---|---|
| 22 | <p>Brake Application Icon (Symbol) appeared for long. Even the duration with Speed Pointer as “White (No brakes, No Overspeed Warning)” itself persisted for 09 Seconds from 12:44:49 Hrs to 12:44:58 Hrs.</p> | OEM HBL RDSO |

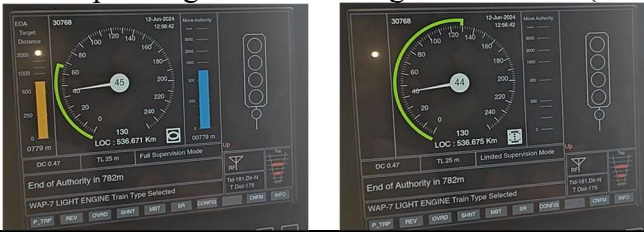
- (C) When Kavach transits to degraded mode, the relaxation in Permitted Speed shall not take place without cognizance by Train Pilot in form of Acknowledgement by Train Pilot. {Item (23) of Enclosure}.

| SN | Actionable Item | Action By |
|---|---|---|
| 23 | <p>Kavach was righteously supervising the train speed with Permitted Speed 66 kmph at ~780m from Up Home Signal on approach at Danger when it suddenly started permitting 130kmph without any acknowledgement form Train Pilot while transiting to such degraded mode at Time 12:56:42. This relaxation in Permitted Speed shall have taken place only after cognizance by Train Pilot in form of pressing of Acknowledgement Button (CoE Ltr 25.03.2024, 09.04.2024)</p> | All OEMs RDSO |
